ProteXus Polyurea Foam Adhesive on Happy Seats

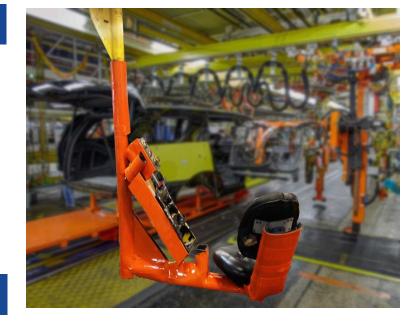
The customer was having a difficult time in their manufacturing process with damage on a fastening installation application. The employees who do the fastening have to sit on an installation device called a "happy seat." The happy seat was coated with a special ballistic cut resistant foam which lasted for 6 weeks in the application. This created markings and damage to the vehicle and downtime.

Exotic's Engineered Rubber & Plastics
Division (ERP) provided a sample of our spray
polyurea to put to test. The material was on
test for 6 months without any visible wear.
The engineering manager over general
assembly issued an edict to have the happy
seats updated with Exotic ProteXus materials
as well as all the installation fixtures.

Exotic's ProteXus Polyurea Foam Adhesive Backed Sheets and Tape- A high grade neoprene foam rubber, coated with a high-performance grade polyurea with a hardness rating of 80A and is proven not to damage Class A surfaces.
